EVALUATION OF MACHINE VISION COLLECTED PAVEMENT MARKING  
QUALITY DATA FOR USE IN TRANSPORTATION ASSET MANAGEMENT

A Thesis

Major Subject: Civil Engineering

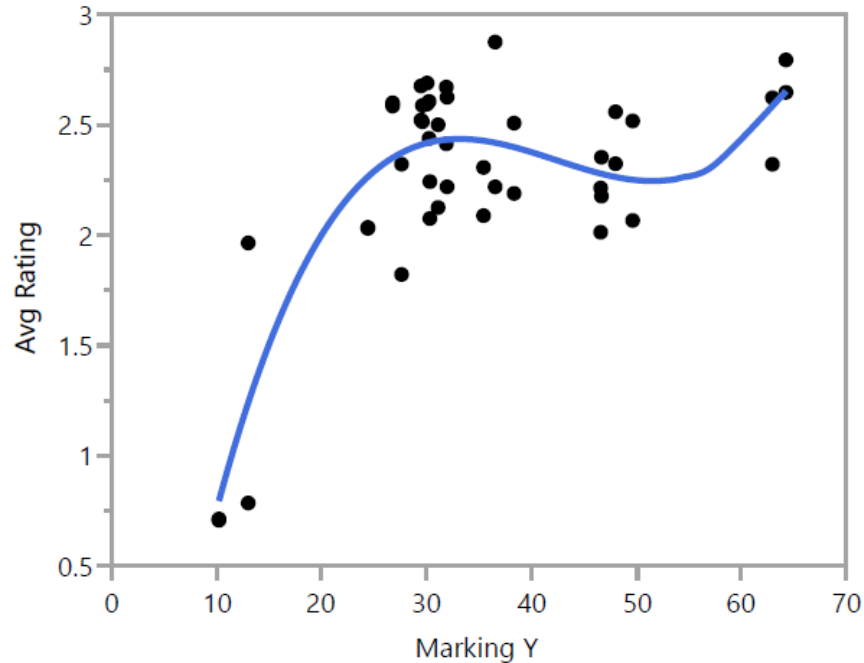
**Figure 43. Daytime Average Marking Quality Score vs. Marking Y**

$$\text{Average Quality Score} = -0.0000619x^3 + 0.00522575x^2 - 0.144011x + 3.72304$$

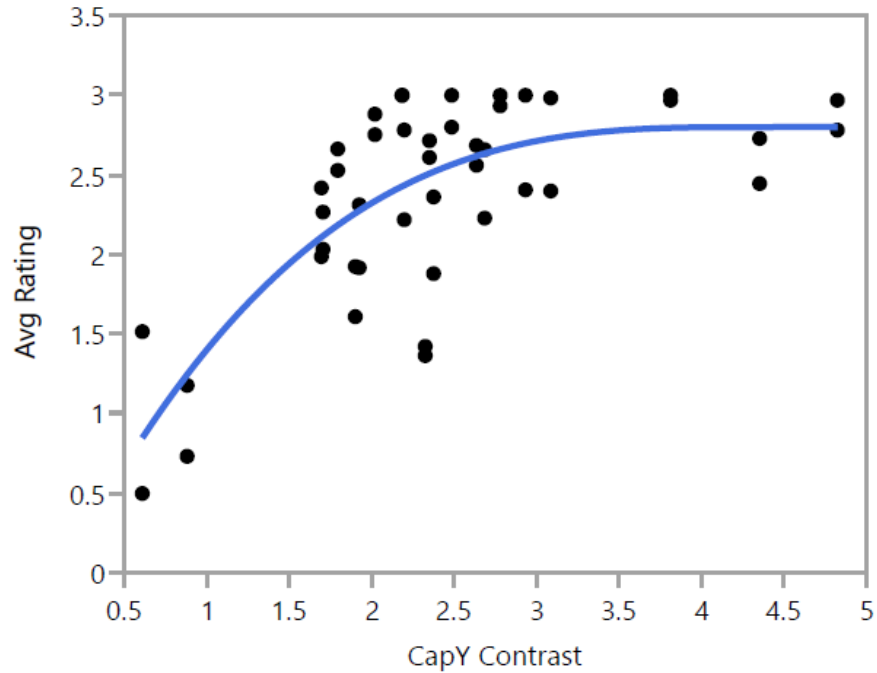
**Figure 44. Nighttime Average Quality Score vs. Cap Y Contrast**

$$\text{Average Quality Score} = 0.0380291x^3 - 0.49435x^2 + 2.13915x - 0.281797$$

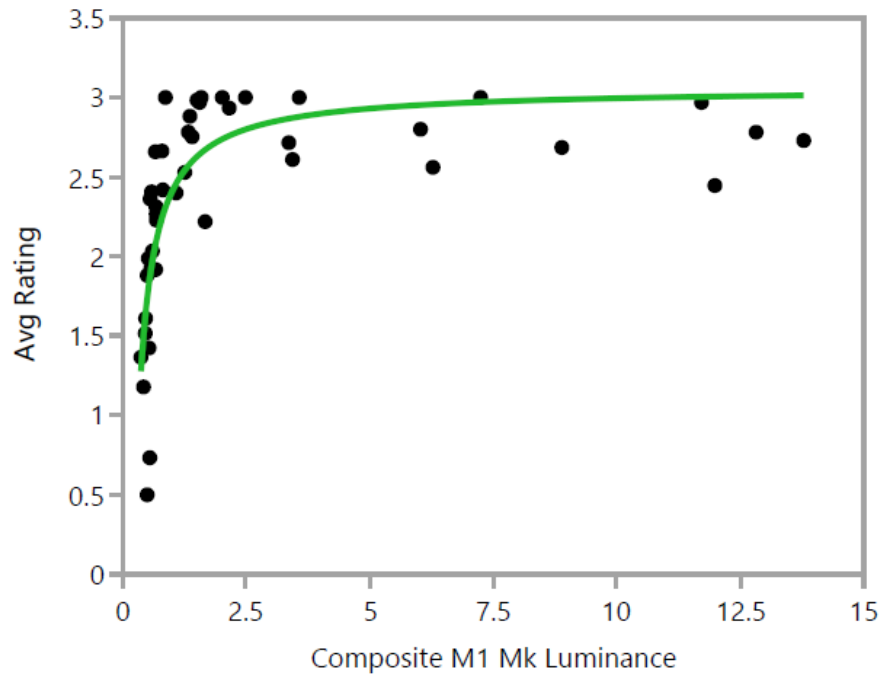
**Figure 45. Reciprocal Transformation Average Marking Quality Score vs. Composite M1 Mk Luminance**

$$\text{Average Quality Score} = 3.0597877 - 0.646328 * \frac{1}{\text{Composite M1 Mk Luminance}}$$

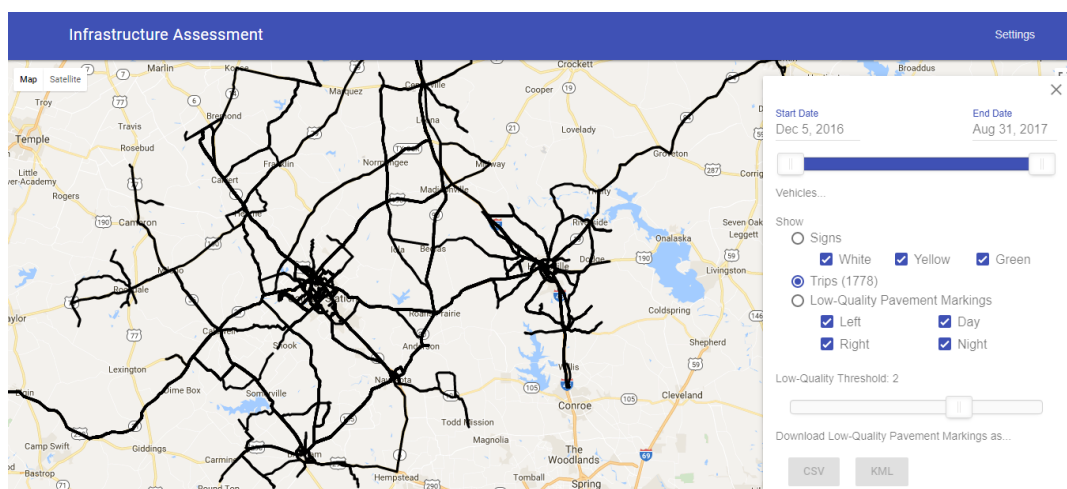
**Figure 46. Example Pavement Marking Inventory Map**

Machine vision technology is easy to integrate and allows for the improvement of current information technology systems and data analysis tools used to support asset management. The most common currently used tools for analysis in pavement marking management are the Microsoft office suite (Excel and Access), Oracle database systems, or GIS interfaces (12, 18). The use of these programs indicates a simpler approach to managing pavement markings when compared with other advanced software management systems for bridges and pavements (18). Implementing machine vision technology for data collection and condition assessments allows for easy incorporation into a GIS or other map interface for data visualization because the data is geolocated automatically upon collection and hosted on a cloud-based server. Efforts have already been made to create an automatically updating map interface showing pavement marking inventory and conditions as shown in Figure 46.
